# HOME REPORT

181 Cloberhill Road  
Glasgow  
G13 2DD

survey report on:

<b>Property address</b>	181 Cloberhill Road Glasgow G13 2DD
<b>Customer</b>	J Cowan
<b>Customer address</b>	181 Cloberhill Road Knightswood Glasgow G13 2DD
<b>Prepared by</b>	DM Hall
<b>Date of inspection</b>	19th March 2009

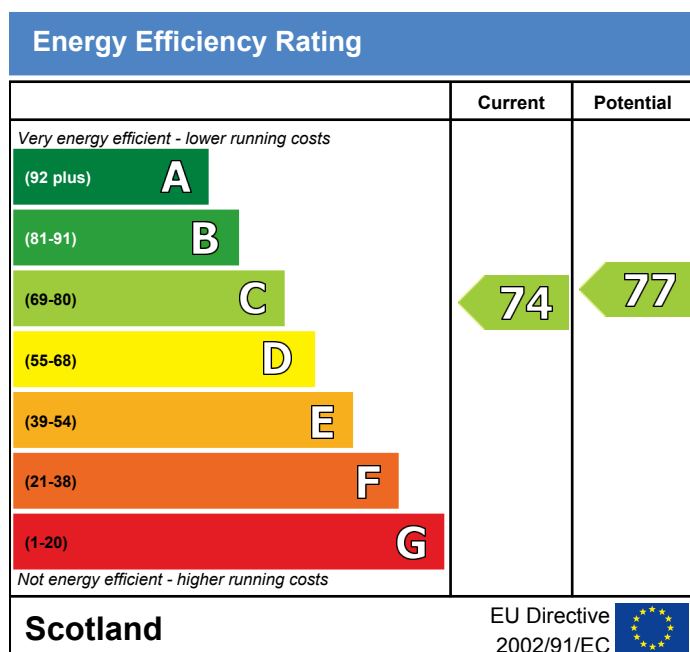
The energy efficiency rating is a measure of the overall efficiency of a home. The higher the rating the more energy efficient the home is and the lower the fuel bills are likely to be.

Approximate current energy use per square metre of floor area: 204 kWh/m<sup>2</sup> per year

This dwelling has been assessed using the RdSAP 2005 methodology. Its performance is rated in terms of the energy use per square metre of floor area, energy efficiency based on fuel costs and environmental impact based on carbon dioxide (CO<sub>2</sub>) emissions. CO<sub>2</sub> is a greenhouse gas that contributes to climate change.

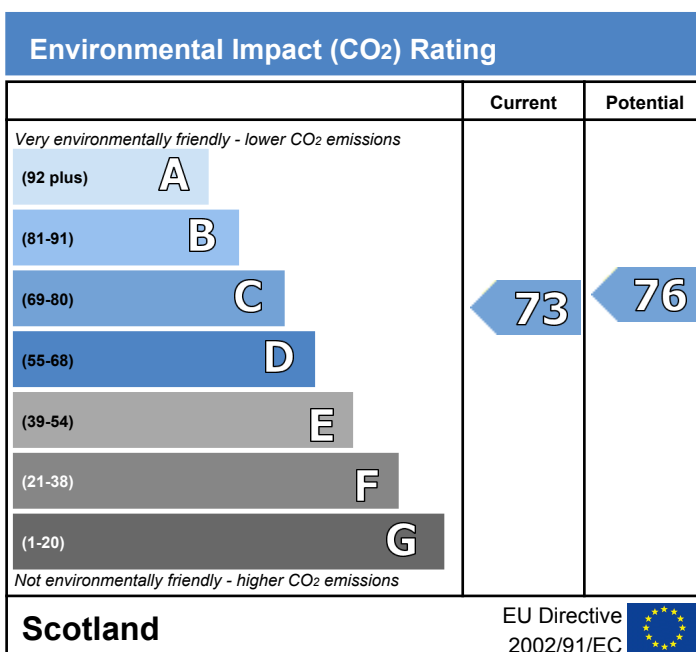
Approximate current CO<sub>2</sub> emissions: 34 kg/m<sup>2</sup> per year

The environmental impact rating is a measure of a home's impact on the environment in terms of carbon dioxide (CO<sub>2</sub>) emissions. The higher the rating the less impact it has on the environment.
