Single Survey

survey report on:

Property address	181 Cloberhill Road Glasgow G13 2DD
------------------	---

Prepared by	DM Hall
-------------	---------

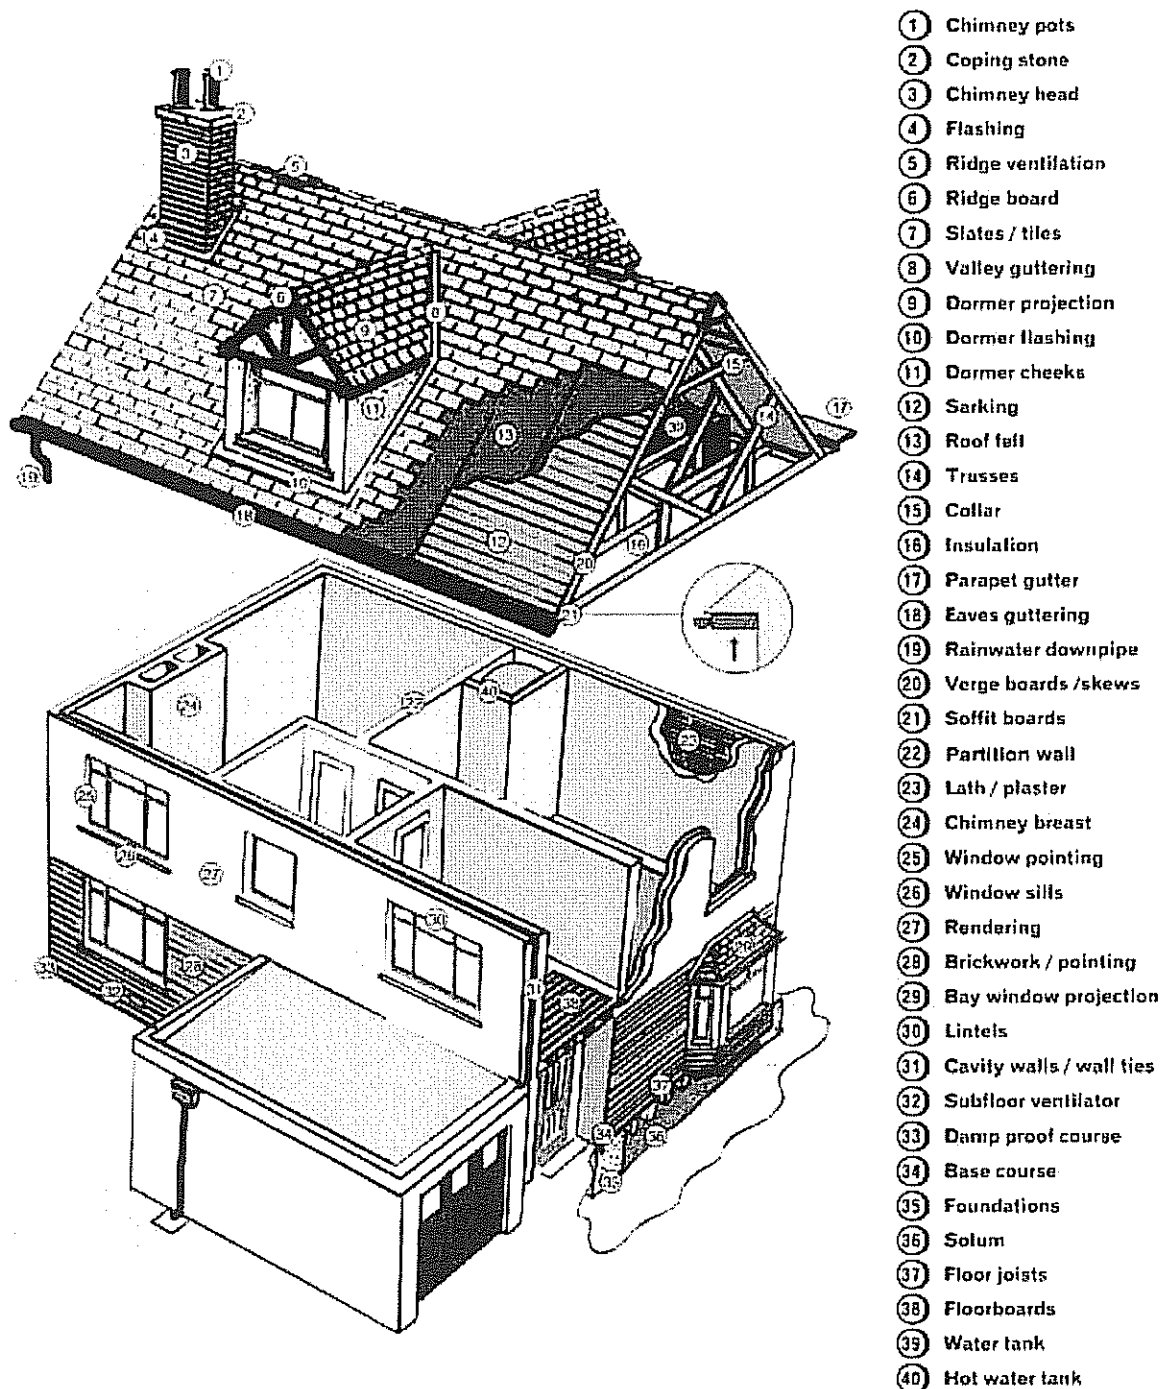
Sectional Diagram showing elements of a typical house

Reference may be made in this report to some or all of the above component parts of the property. This diagram may assist you in locating and understanding these items.
